Buildings & Environments

SPRING 2024

by Adam Sanders and Francesco Labianca – Elara Engineering

Things You Need to Know About Kitchen Waste Piping and Garbage Disposals in Chicago Condos & Apartments

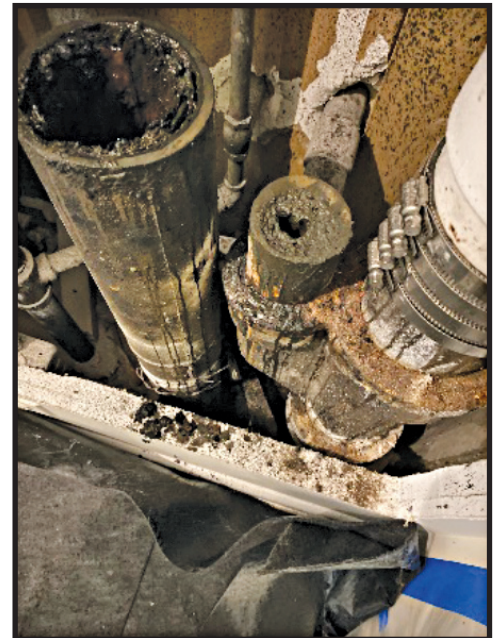
Shown here is an image of grease buildup in kitchen waste piping that undergoes regular maintenance.

tain minimal functionality while continuing to experience clogs. Several buildings with garbage disposals reportedly perform kitchen waste piping maintenance more frequently with the most frequent maintenance efforts being 12 times a year. See the image on the prior page of grease buildup in kitchen waste piping in a large multi-family building that undergoes regular maintenance.

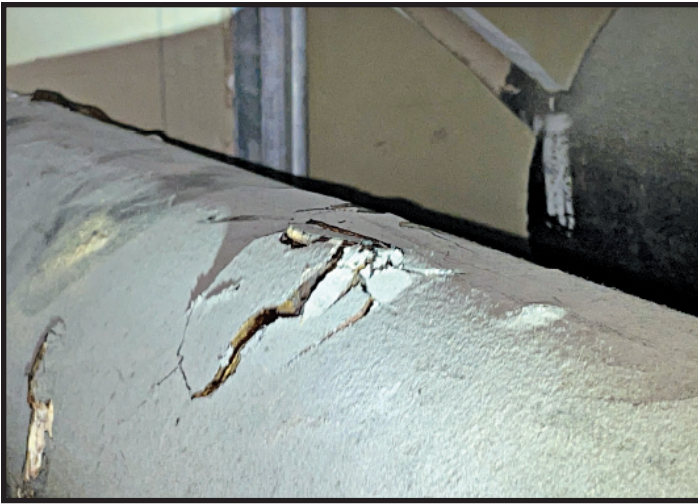
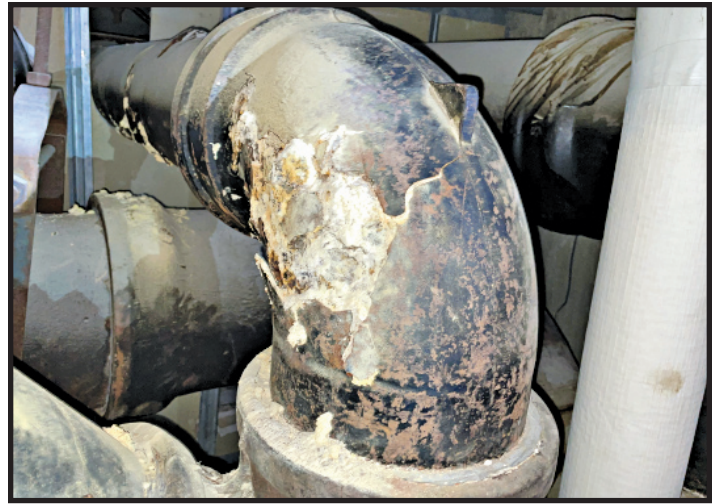
Shown here are examples of cast iron kitchen waste piping that demonstrate failures resulting in the process described in this article.

grease. Improper pitch and/or lack of regular thorough maintenance will further contribute to additional grease and food waste deposits in the piping. Additionally, food deposits decompose over time resulting in acidic off-gassing which condenses into a liquid, coating the interior of the pipe in a corrosive liquid. Over time, the liquid corrodes the cast iron kitchen waste piping from the inside out, shortening the lifespan of the piping. The pictures on this page are examples of cast iron kitchen waste piping that demonstrate failures resulting in the process described above.
